Manhole Inspection Summary

Manhole # S47II_037MH

Location Address: **Federal St**

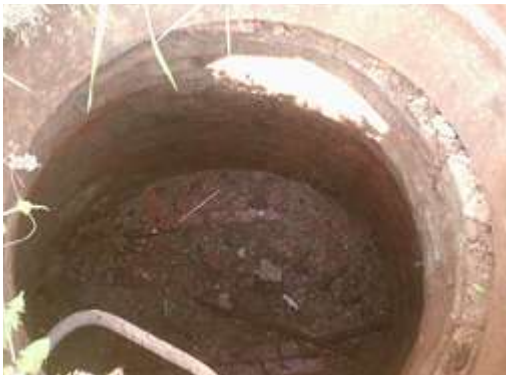
Defect 1

Frame Offset: **1** (in.) Condition: ☐ Sound ☐ Cracked ☒ **Leaks**

Frame Leaks

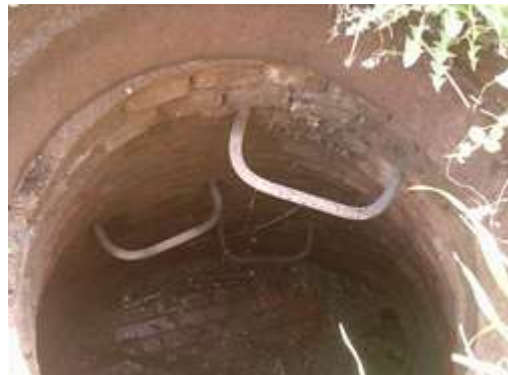
Defect 2

Condition: ☐ Sound ☐ Cracked ☐ Root Intrusion ☒ **Loose Brick** ☒ **Deteriorated**

Deterioration/Loose Bricks

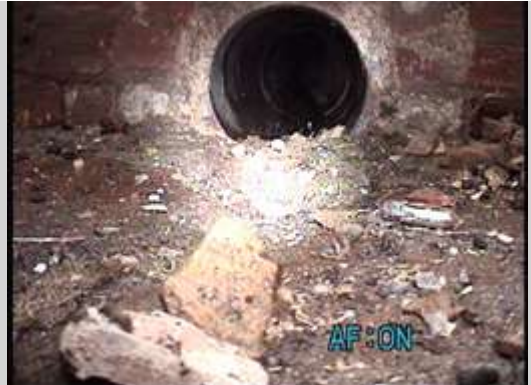
12 O'Clock Outflow

8 in. Circular Gravity Sewer
Pipe Out @ 12 O'Clock

Deposits: ☐ None ☐ Mud ☐ Sludge ☒ **Debris** ☐ Grease

Silt Depth: **1** (in.) Deposits Extent: **Light**
